Комитет за истрага на воздухопловни несреќи и сериозни инциденти  
Aircraft Accident and Incident Investigation Committee

**FINAL REPORT**  
**on a Serious Incident**  
**КИНСИВ 008/2025**  
**Airborne Near Mid-Air Encounter**  
between two aircraft:  
**Airbus A320 HA-LYS and Cessna 172 Z3-DCL,**  
in the vicinity of **Skopje International Airport**, at **FL040**,  
which occurred on **17 September 2025 at 05:45 UTC**.

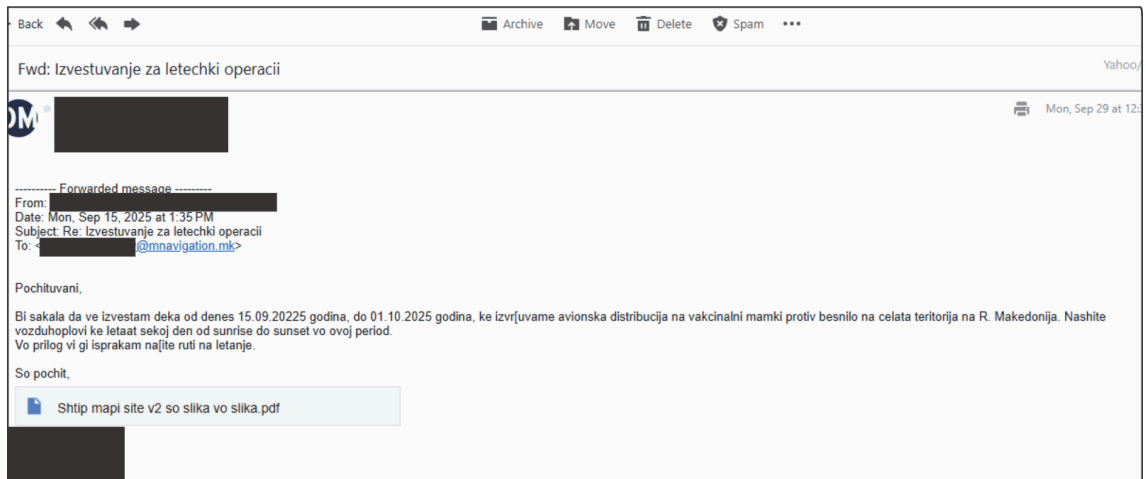
**Figure 7: Preparatory e-mail to M-NAV**

In the e-mail, the operator notified M-NAV that aerial distribution flights of oral rabies vaccine baits would commence. Attached to the e-mail were all planned flight routes, **including Route No. 64**, for the purpose of operational coordination with M-NAV.

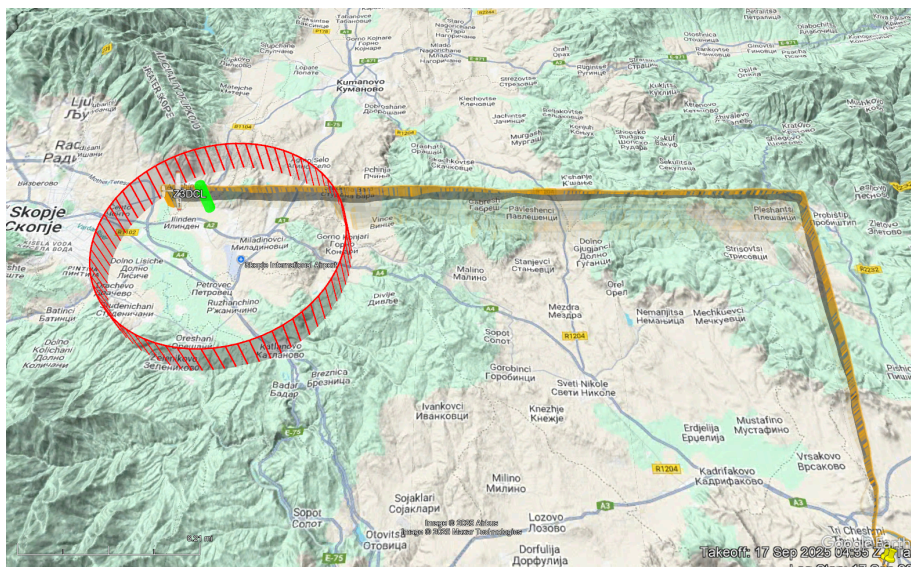
Figure 11: Position of Z3-DCL on the Eastbound Track

No further communication with **Skopje Approach** took place until **07:44**, when the crew reported that they were on the **extended runway centreline** and that another aircraft had passed in close proximity.

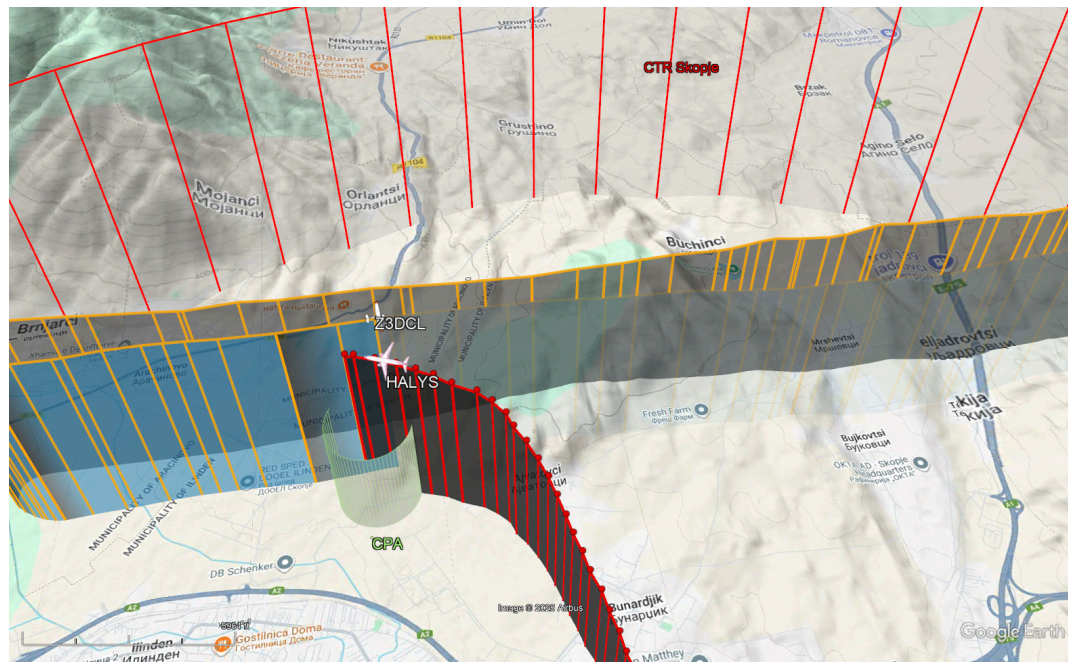
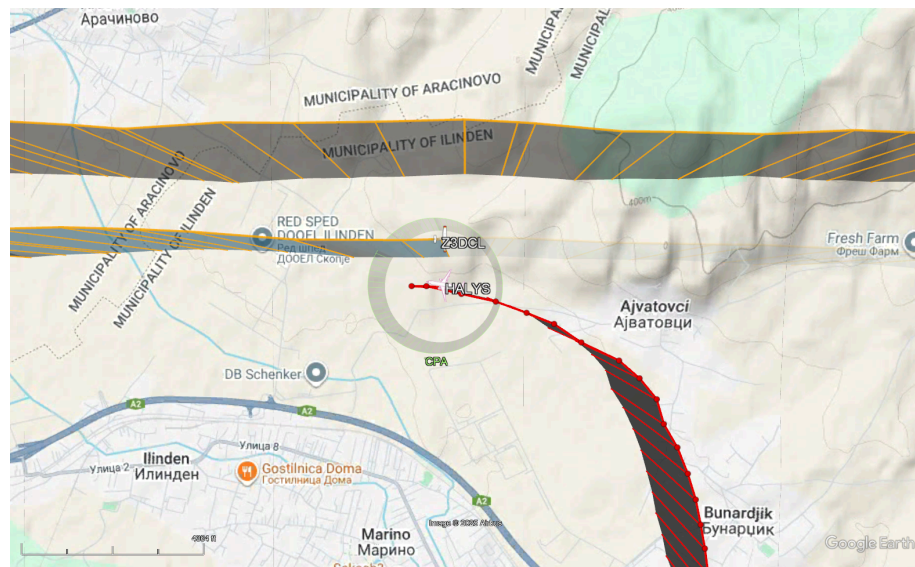
**Figure 15: Positions of Z3-DCL and HA-LYS at the Closest Point of Approach  
07:45 (Local Time)**

According to the flight crews' statements, the crew of **Z3-DCL** observed **HA-LYS** to their right and initially believed it was performing an avoiding manoeuvre. The crew of **HA-LYS** visually acquired **Z3-DCL** after rolling out of a left turn, at an estimated distance of approximately **100 m**, also to their right.

At **07:45:10 (local time)**, both aircraft reached their **minimum horizontal separation distance**, corresponding to the **Closest Point of Approach (CPA)**.

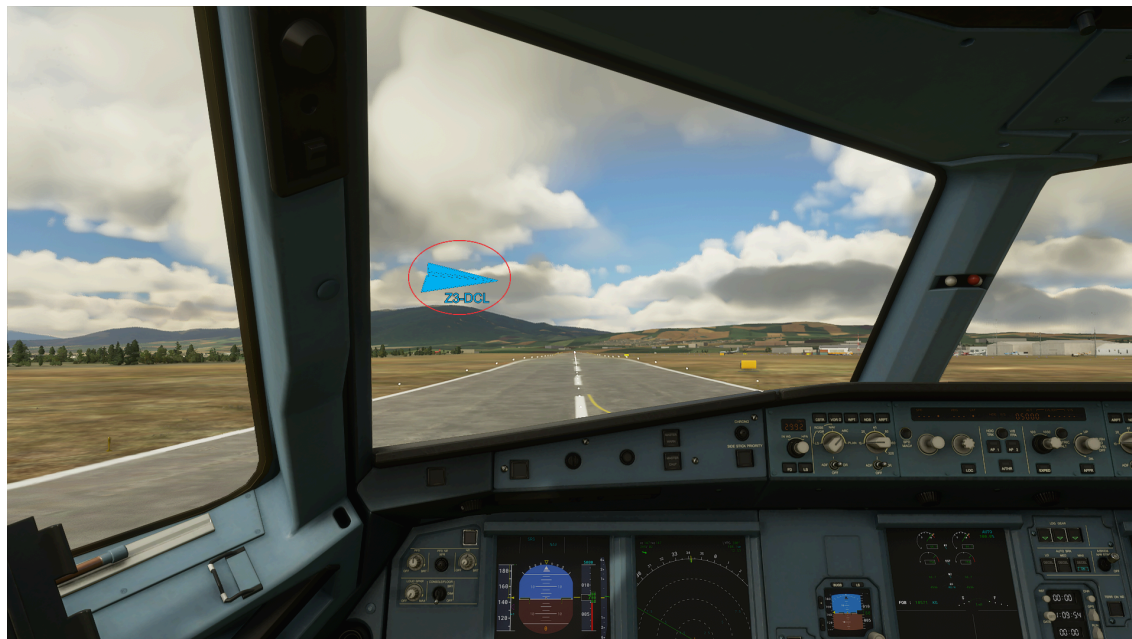
**Figure 19: View from the cockpit of HALYS during the take-off roll and initial climb, and the probable position of Z3DCL**

At that moment, the distance between the aircraft was approximately **9.5 kilometres**. According to the sources consulted by the Committee, the maximum distance at which the human eye can detect an object with dimensions comparable to those of Z3DCL ranges between **7 and 10 kilometres**, provided that the observer knows the direction and the specific sector of the sky in which the observation should be conducted.

Furthermore, the wingspan of Z3DCL is approximately **11 metres**, which at these distances corresponds to an angular size of approximately **2 arc minutes** – a value close to the threshold of human visual perception. Therefore, it can be concluded that the HALYS flight crew would not have been able to visually detect Z3DCL at an altitude of **4000 feet**, even if they had intentionally focused their observation towards the relevant area of the sky.

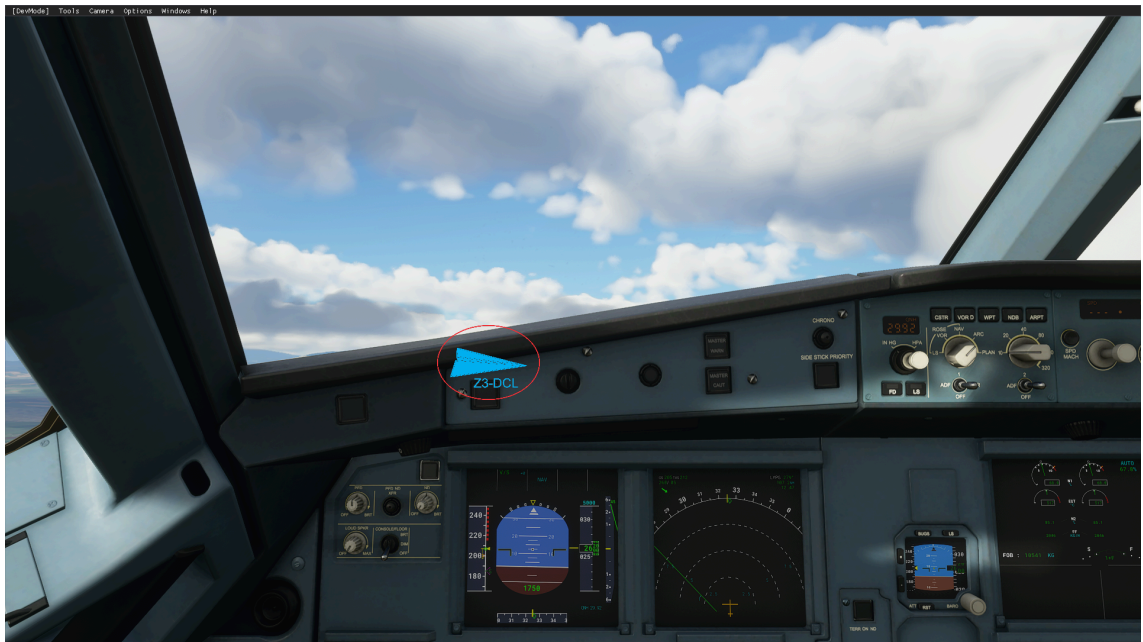
**Figure 20: View from the cockpit of HALYS after take-off, during climb, and the probable position of Z3DCL**

Immediately after take-off, HALYS established a climb angle of approximately  $15^\circ$ . With this aircraft attitude, the cockpit structure and the aircraft nose effectively obstructed the area in which Z3DCL was most likely located. As a consequence of this obstruction, visual detection of Z3DCL by the HALYS flight crew was not possible.

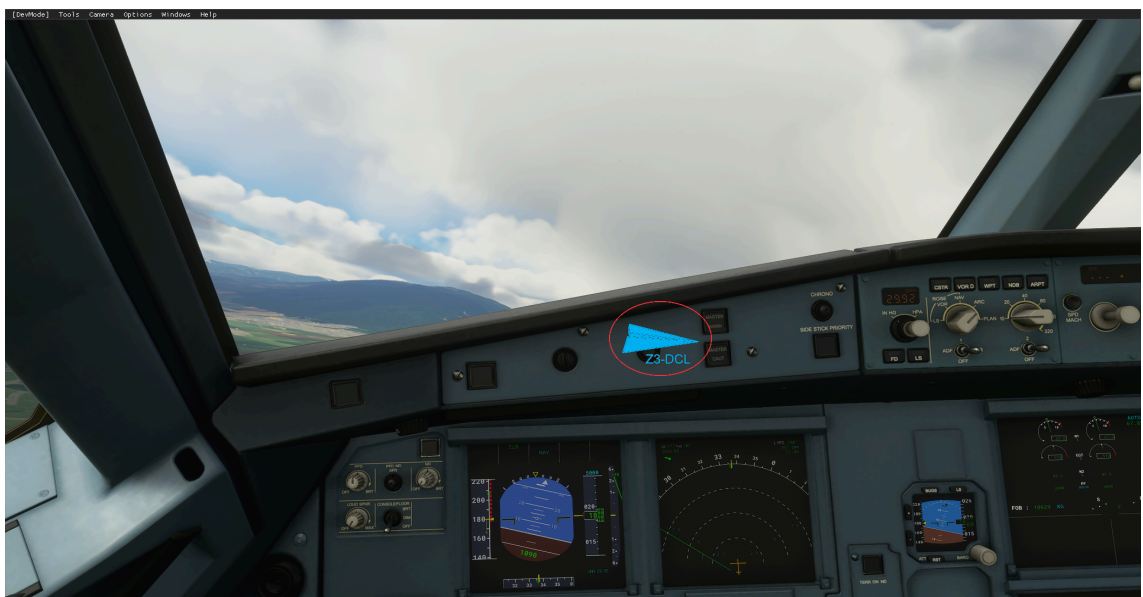
**Figure 21: View from the cockpit of HALYS during the left climbing turn and the probable position of Z3DCL**

Once HALYS initiated the left turn towards the GOSTI waypoint, the cockpit structure again obstructed the most probable position of Z3DCL. From that moment onwards, the possibility of visual detection of Z3DCL by the HALYS flight crew was effectively excluded.
