# For the investigation of the accident of the aircraft PIPER 34 Seneca II, With registry markings D-GLLW, happened on 06.09.2016 in Skopje, Republic of Macedonia

Version:	0.2
Date:	04.12.2018.
Ref. number:

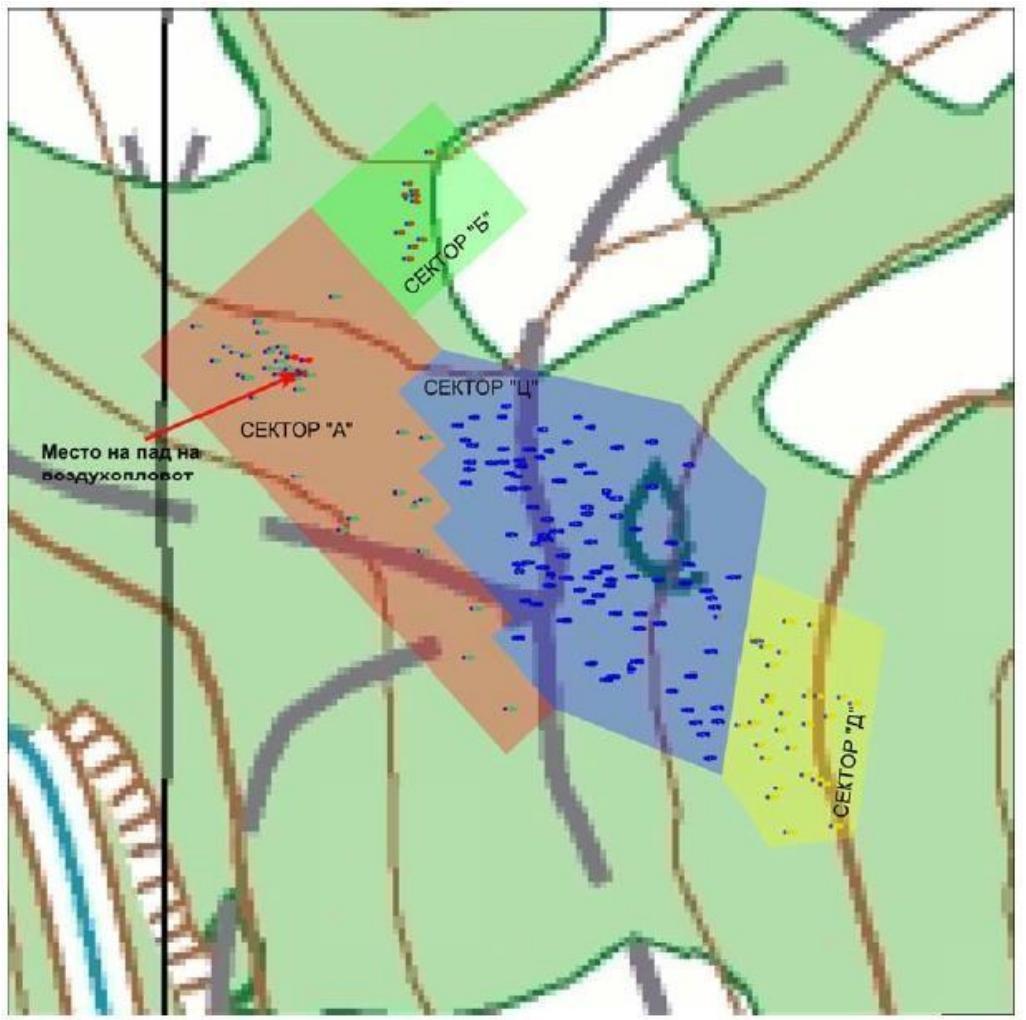
Image 6 Disposition of debris according to sectors

The remains and parts of the aircraft are widespread on the northern and eastern slopes of the hill to an area of about 2.5 ha. The area on which the remains are spread according to the Geodetic Cadastre Information System belong to the cadaster parcels KP 2013, KP 2017, KP 2018, KP 2019, KP 2020, KP 2021, KP 2026 of the Cadaster Plan with the nomenclature 7I9- 15 in the cadastral municipality of Kozhle.

The greatest distance between the markings of the remains and parts of the aircraft is 290 m in the north-west direction and 90 m in the north-east direction.

The positioning was performed on the found remains and parts of an aircraft that were previously signalized with visible numbered markers and divided into four sectors:

- Sector A with 40 markers;
- Sector B with 11 markers;
- Sector C with 95 markers;
- Sector D with 29 markers.

- In an uncontrolled flight, the aircraft receives an uncontrolled speed along a spiral track.
- The prevalence of parts of the aircraft on the ground, their position in relation to the fuselage, as well as the traces of the impact on the ground indicating the vertical path of movement of the remains found at the on-site inspection, indicate that the disintegration of the aircraft has started in the air.

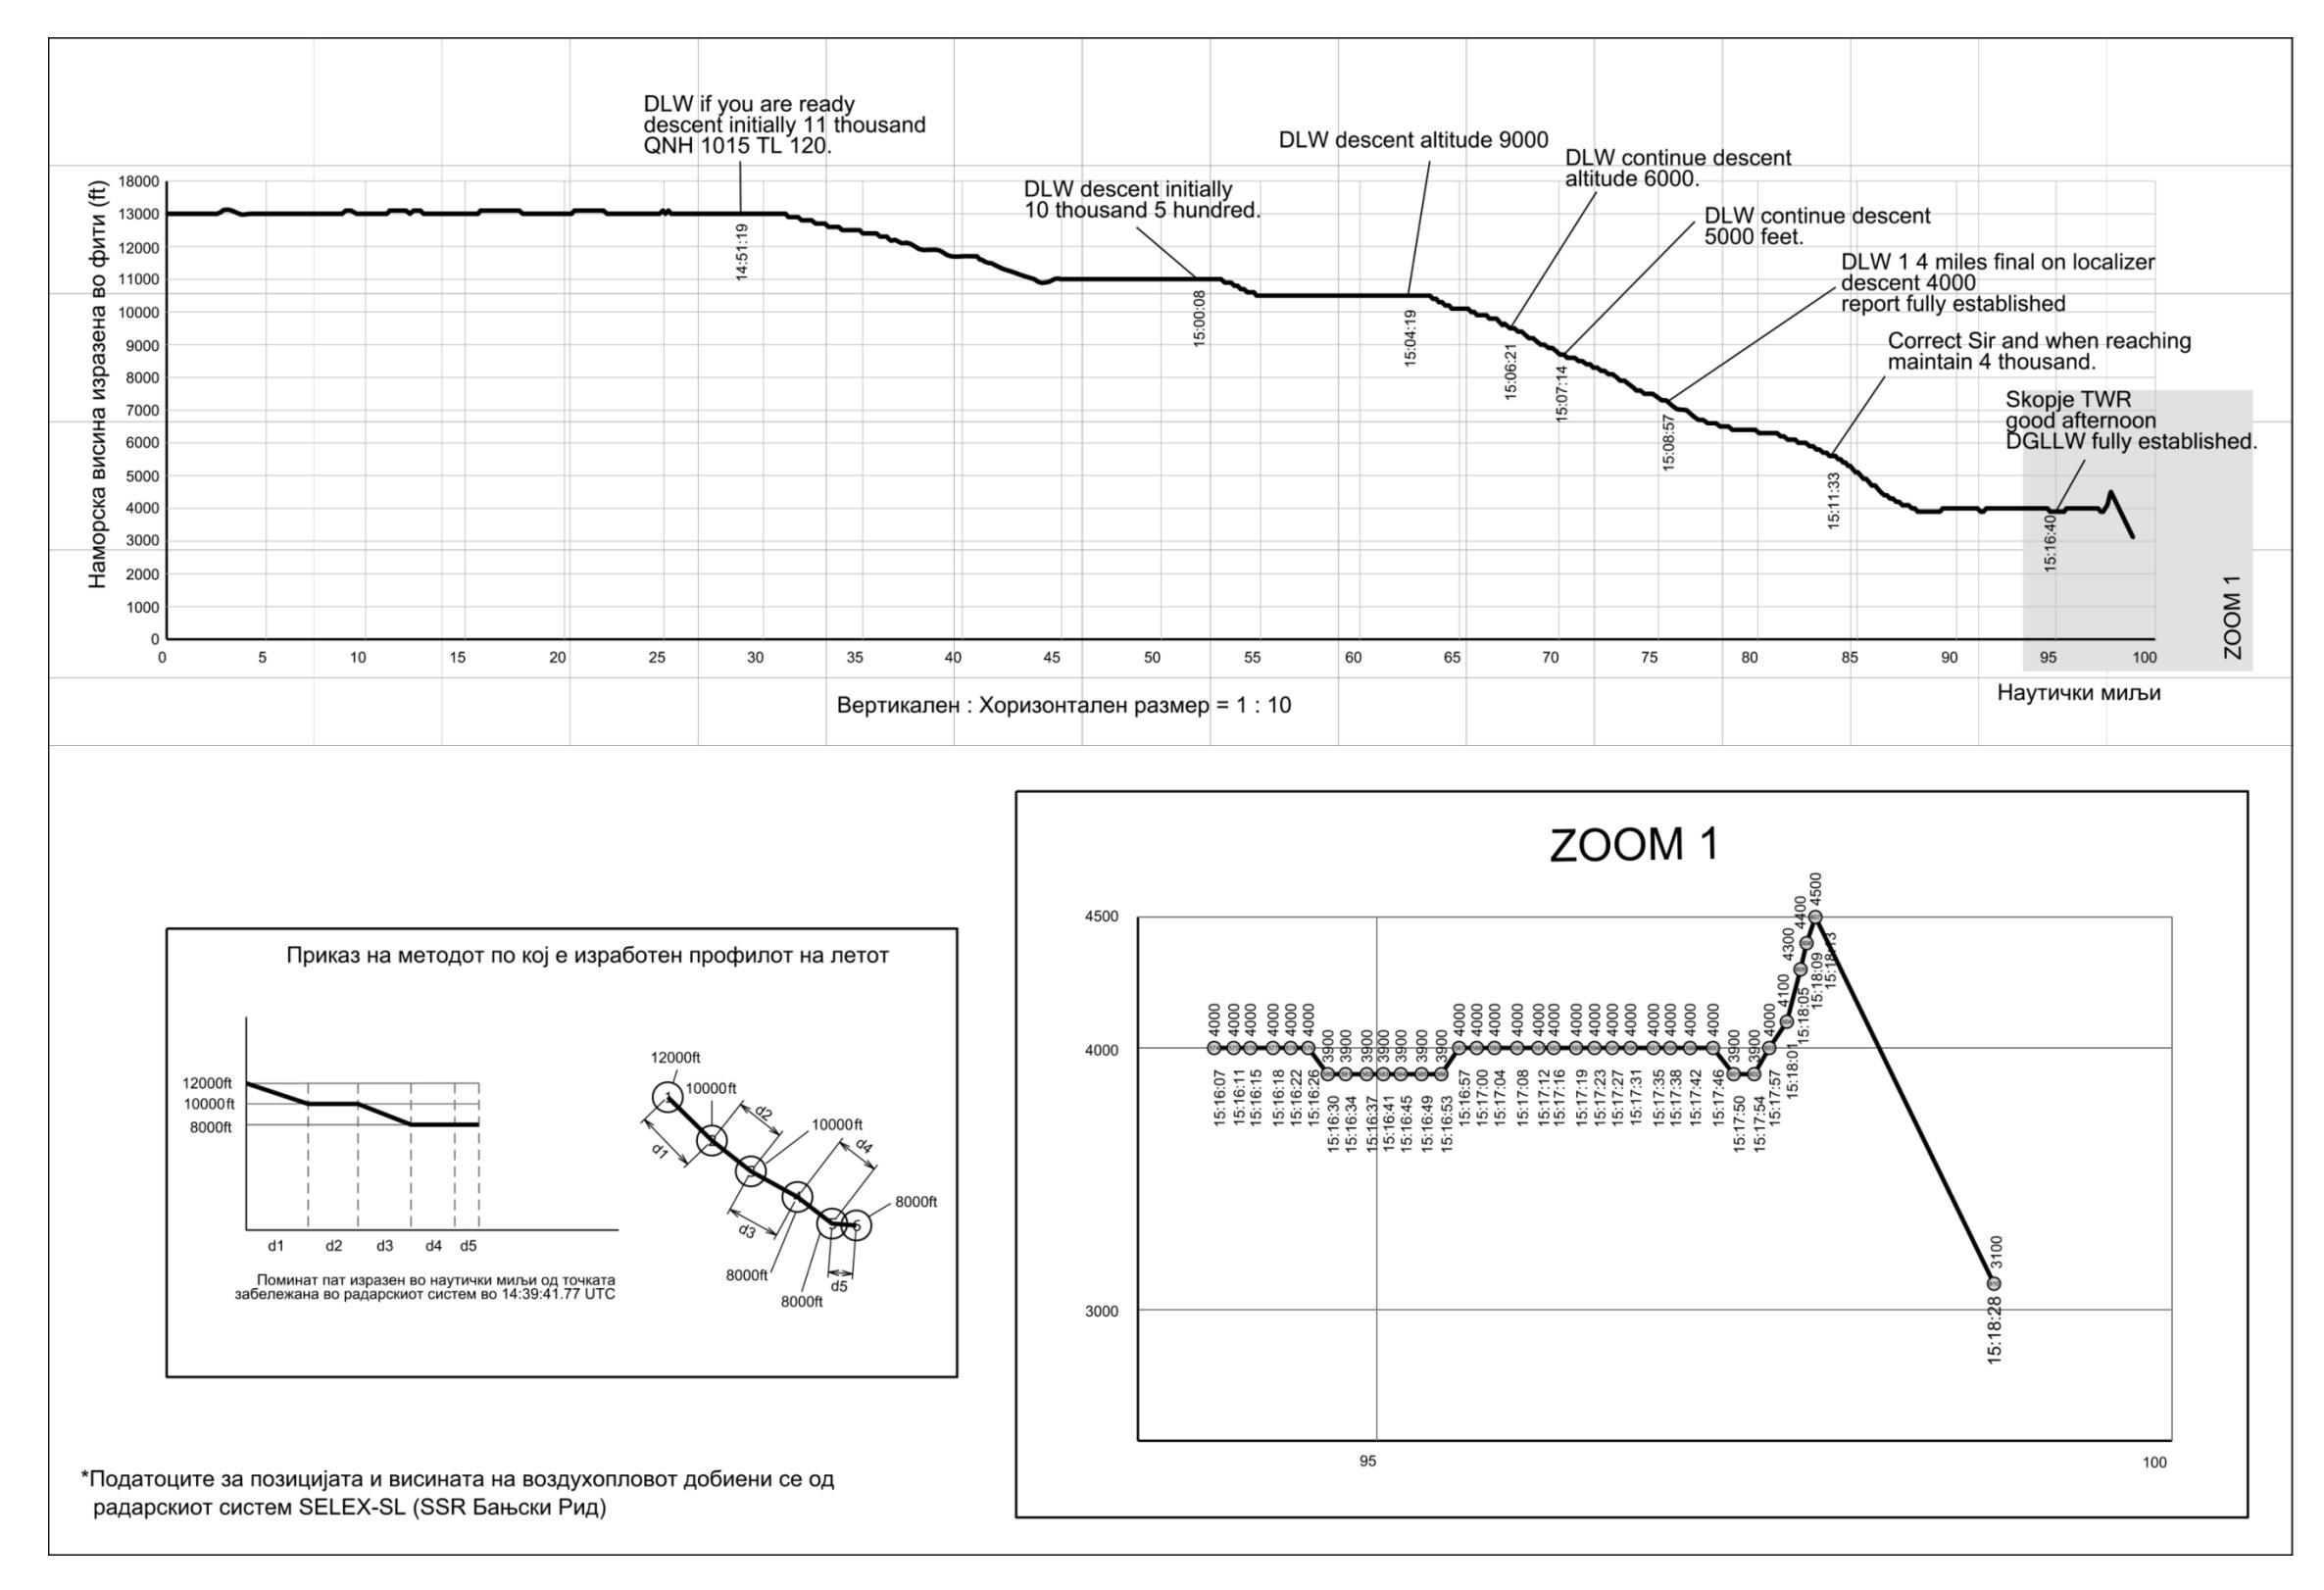
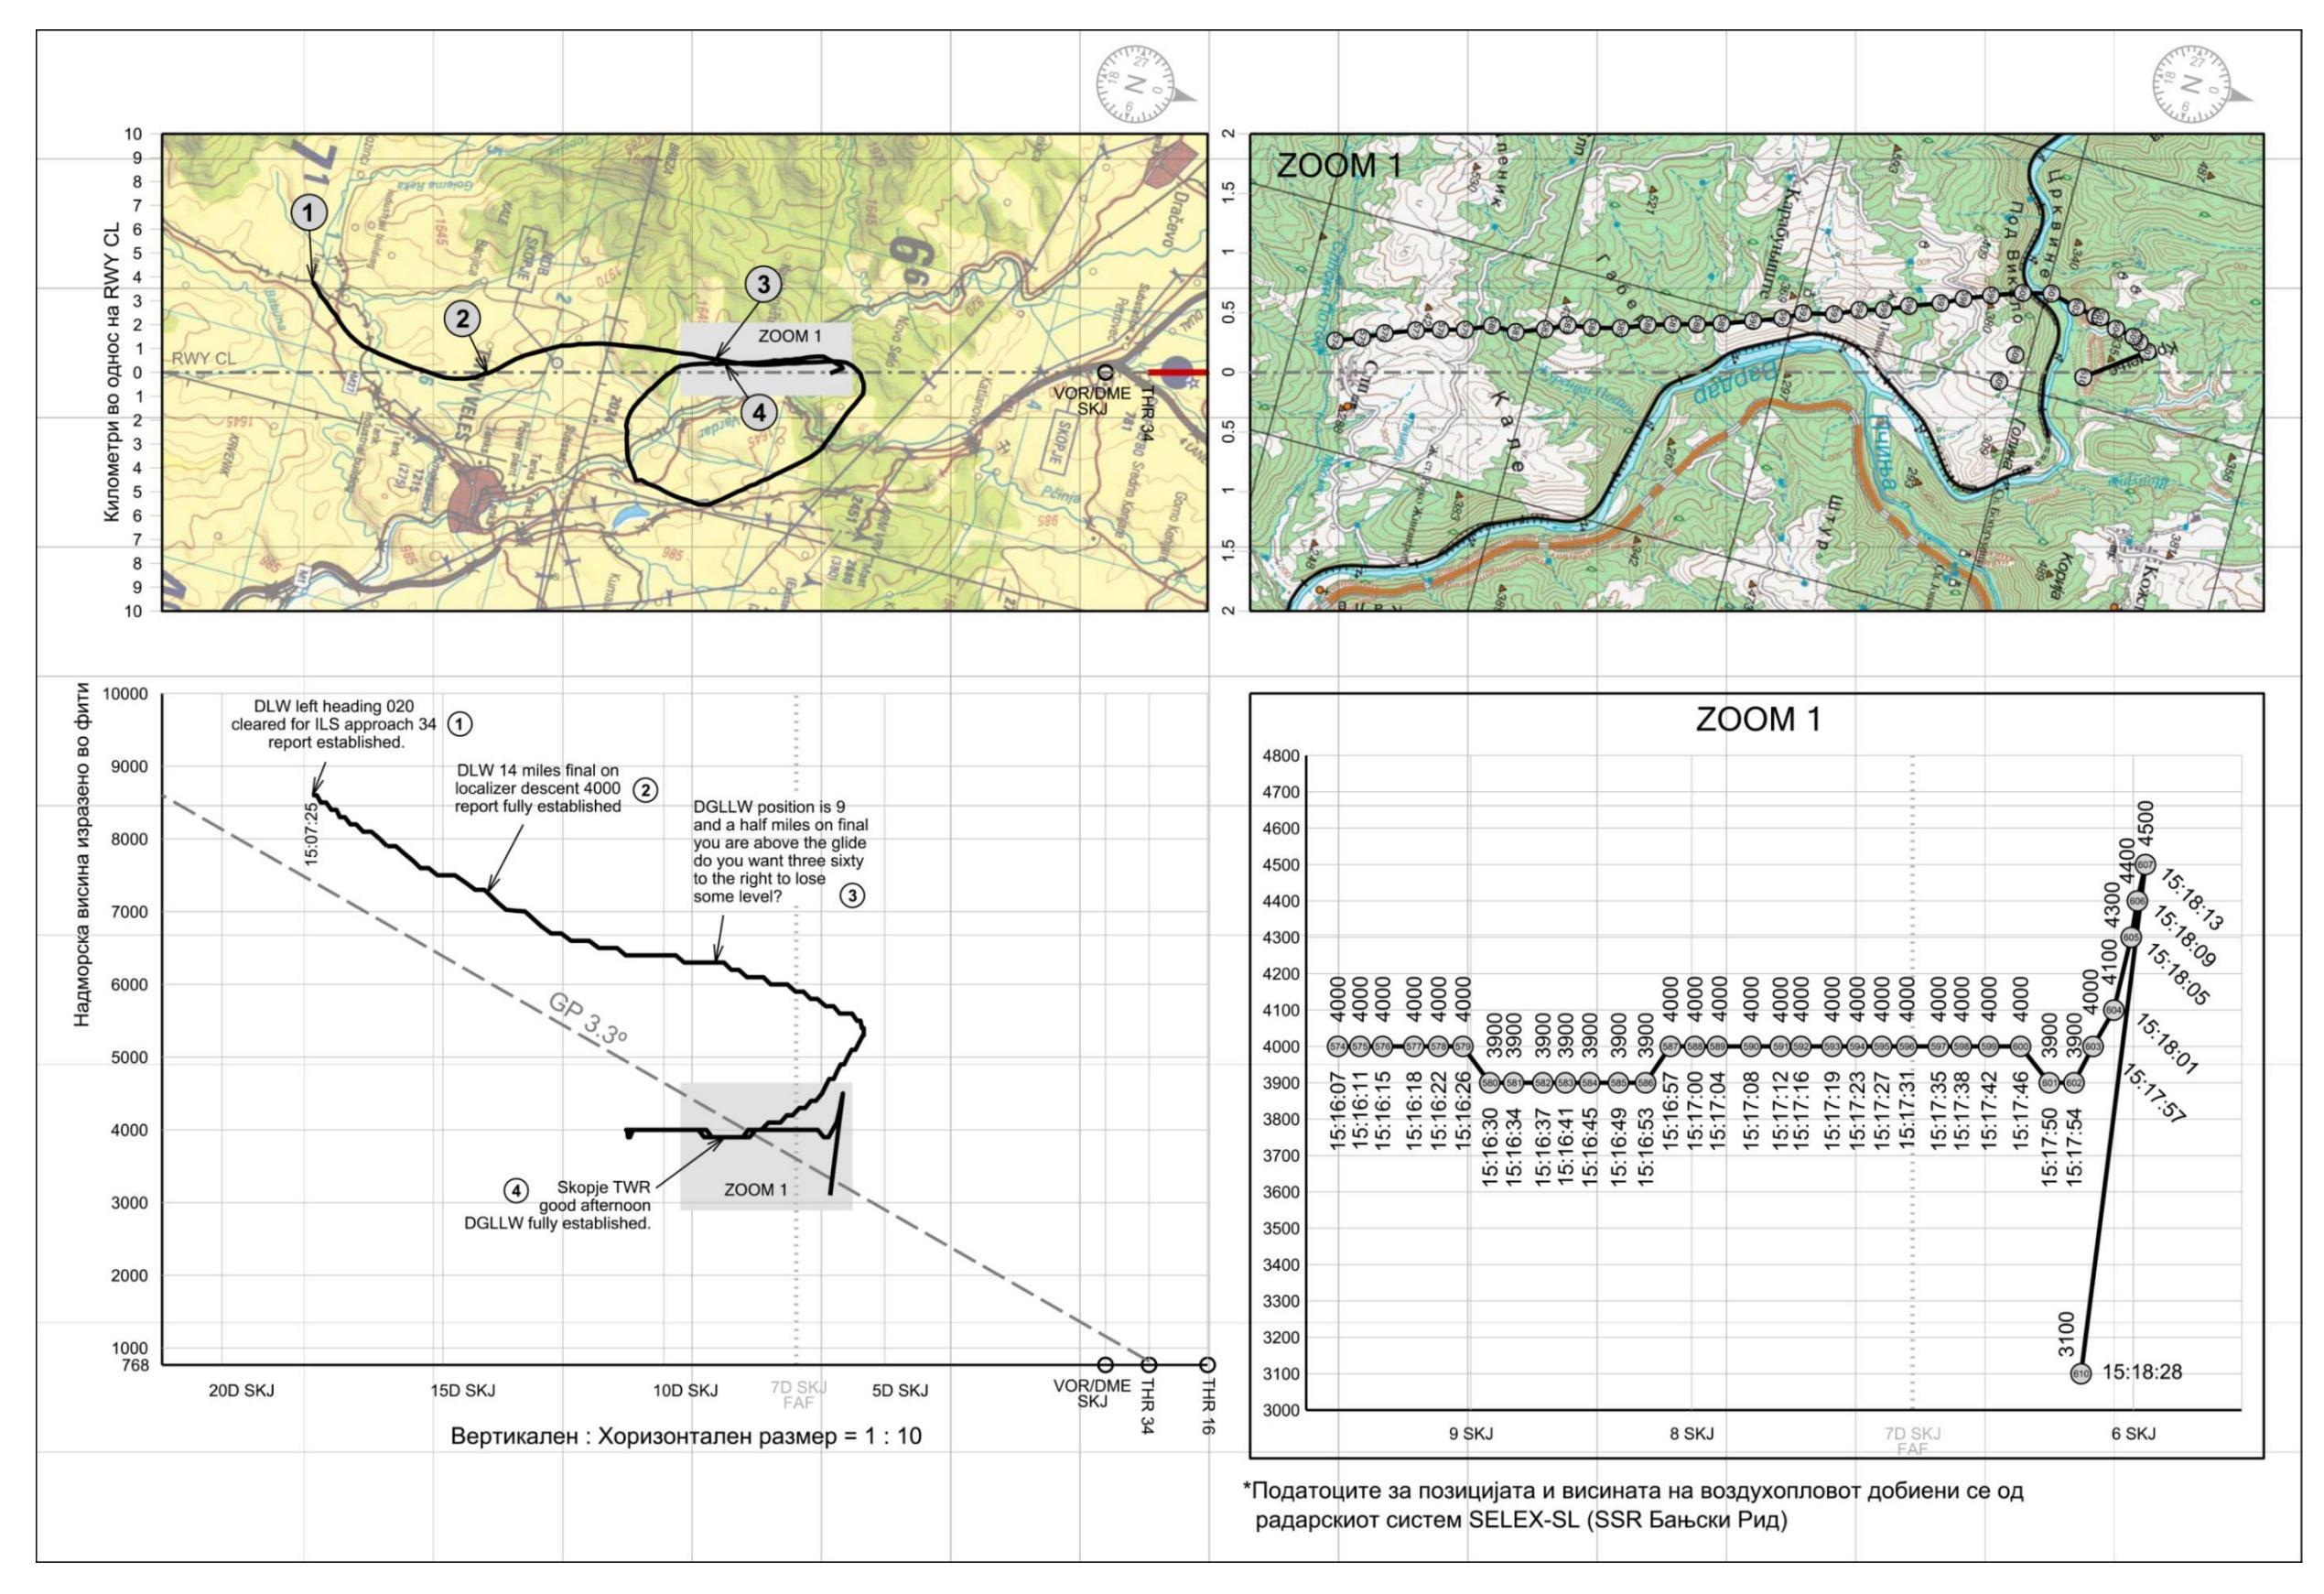
Image 8 Horizontal and vertical profile of the flight

- During the flight, until the beginning of the reduction, the captain did not declare any deviation from the planned and approved flight plan nor any technical problem with the aircraft. The aircraft, for unknown reasons, enters into a state of coarse flight movement a stooling, which has caused entry into a state of uncontrolled flight.

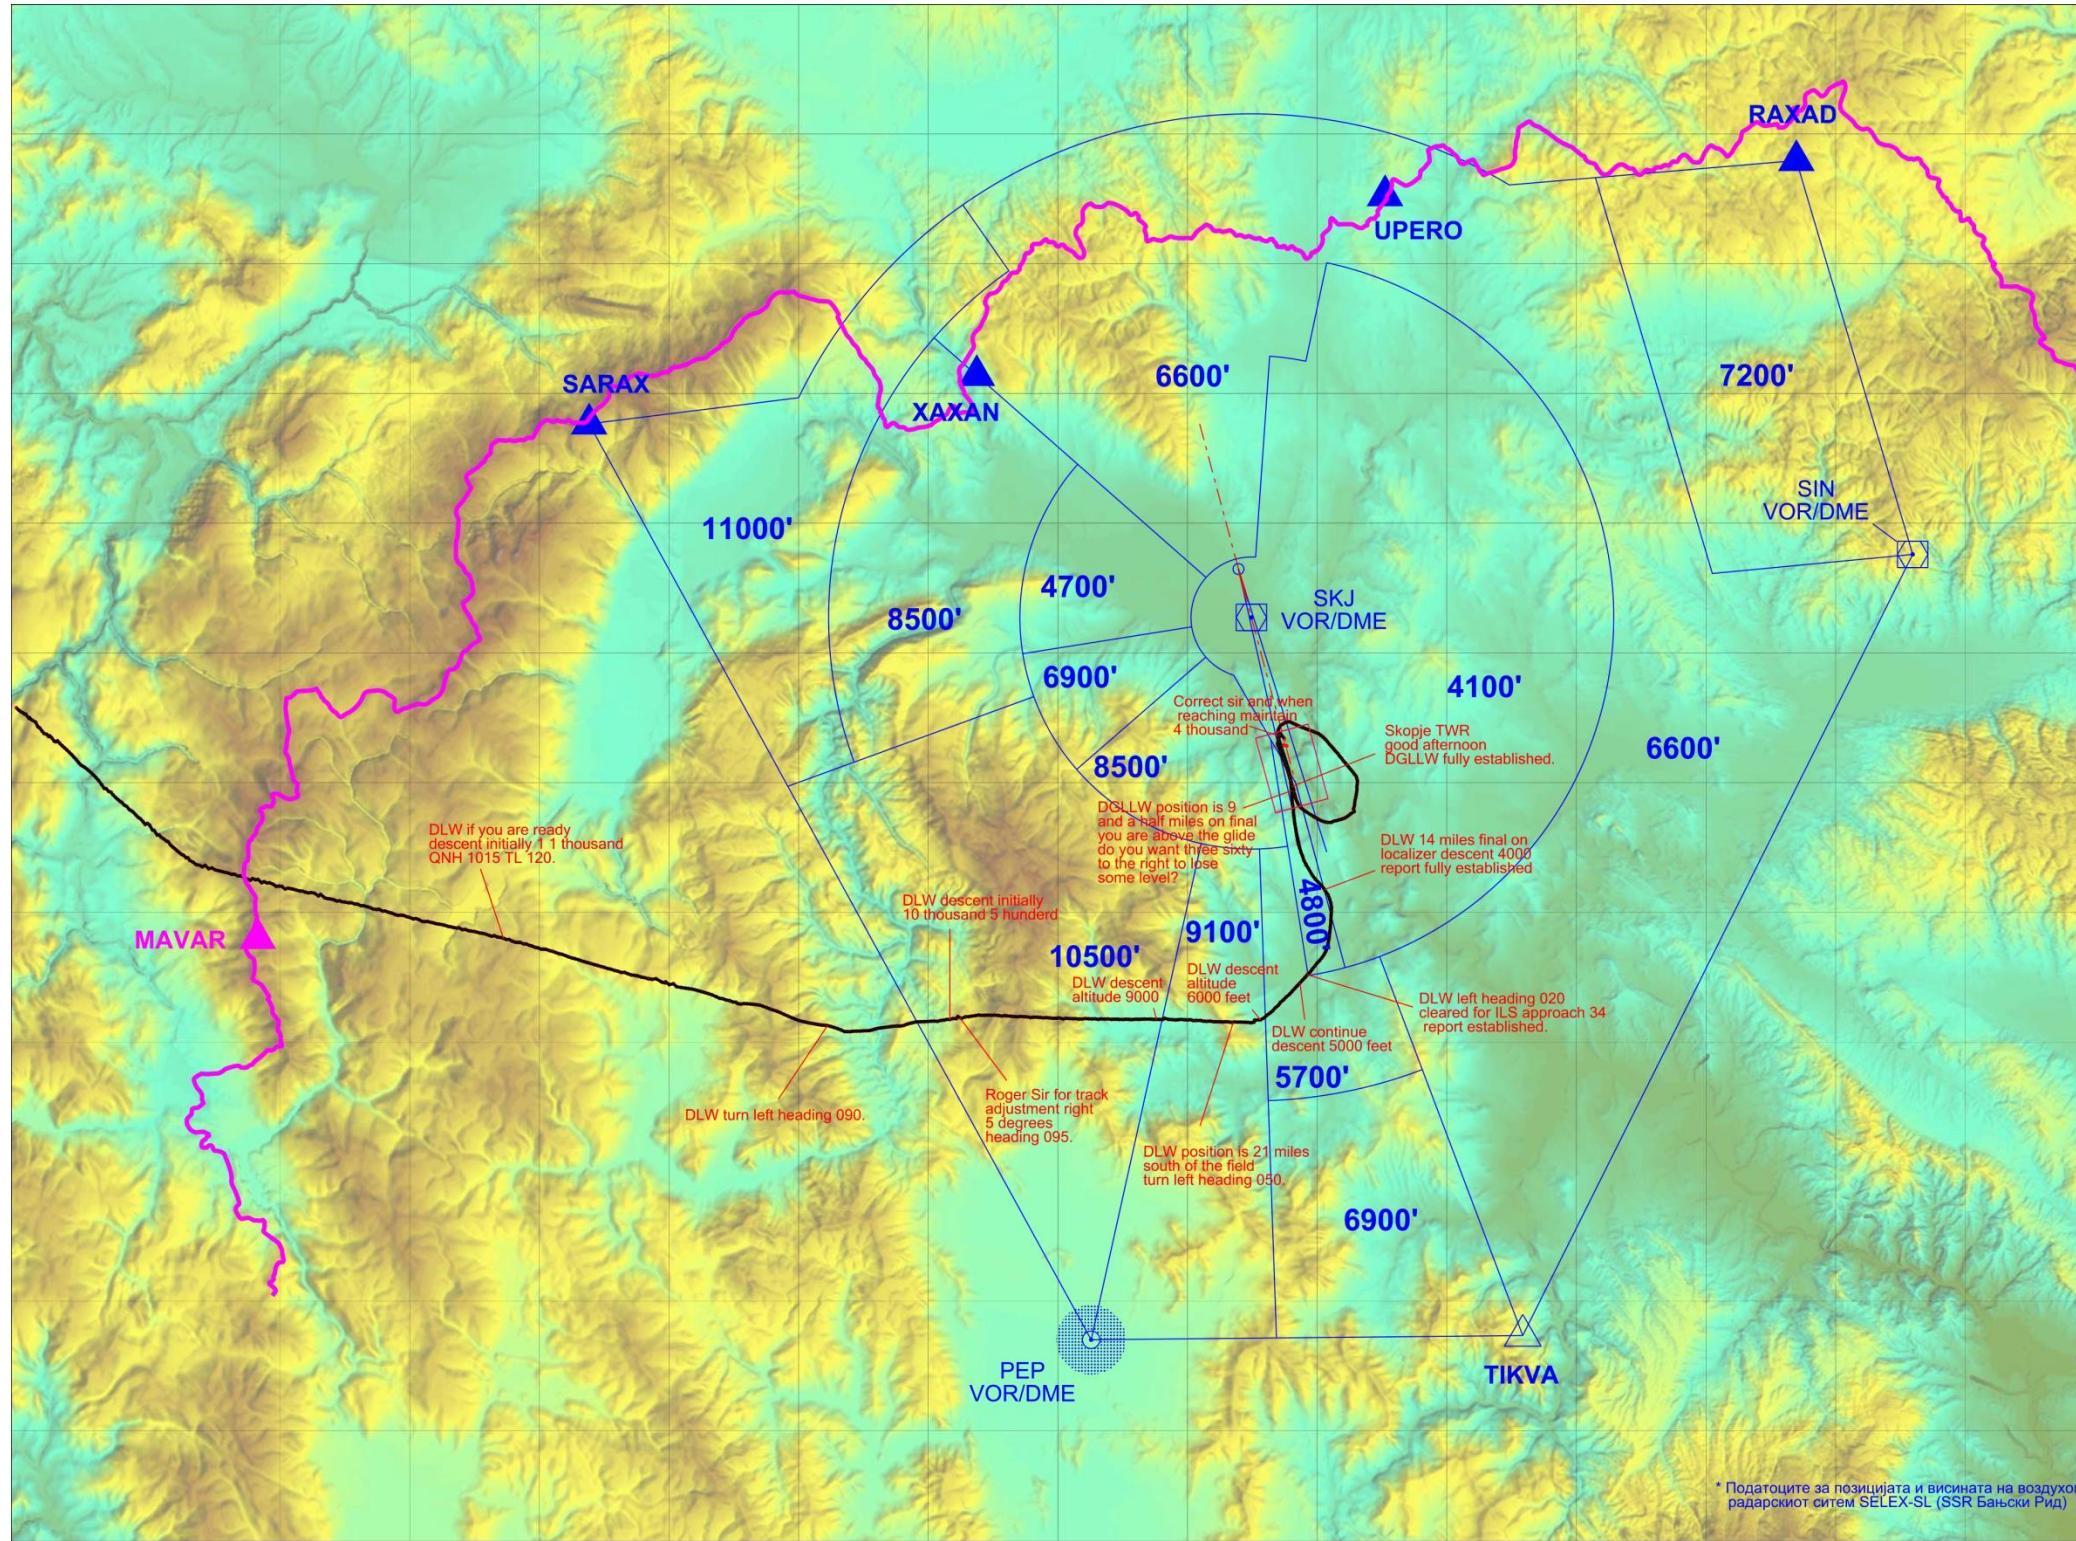
Image 9 Horizontal path of the aircraft

This assumption is based on the movement of an aircraft detected by the radar system, as well as from the position of the remains found at the scene of the accident.
