# For the investigation of the accident of the aircraft PIPER 34 Seneca II, With registry markings D-GLLW, happened on 06.09.2016 in Skopje, Republic of Macedonia

Version:	0.2
Date:	04.12.2018.
Ref. number:

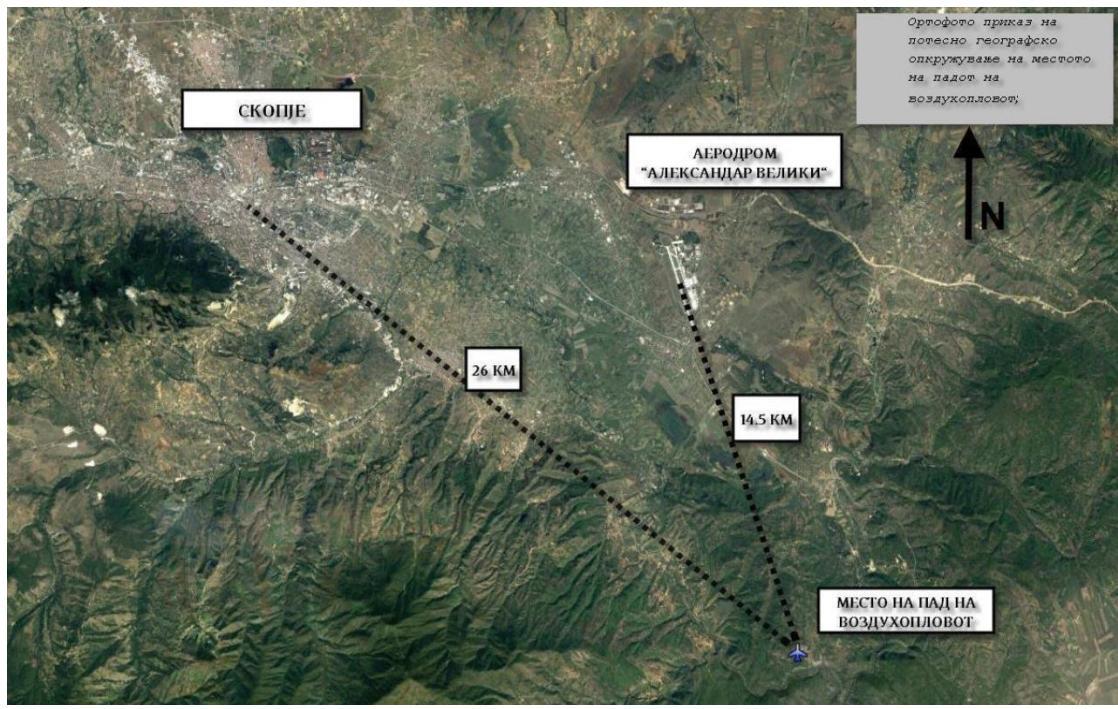
Image 3 Accident site – general orientation

The accident site itself is part of a wider hilly region that spreads from the river Vardar and the river Pcinja, all the way to the Skopje valley. Relief is a mountainous terrain rising north of the valley of the river Vardar with a distinctively steep slope with a height difference of about 135 meters from the base to the top of the hill and continues to the north with a slight decent in height. The eastern and western slopes end up in streams with occasional watercourses. Most of the surface of the hill is forested with low and middle stubble oak forest.

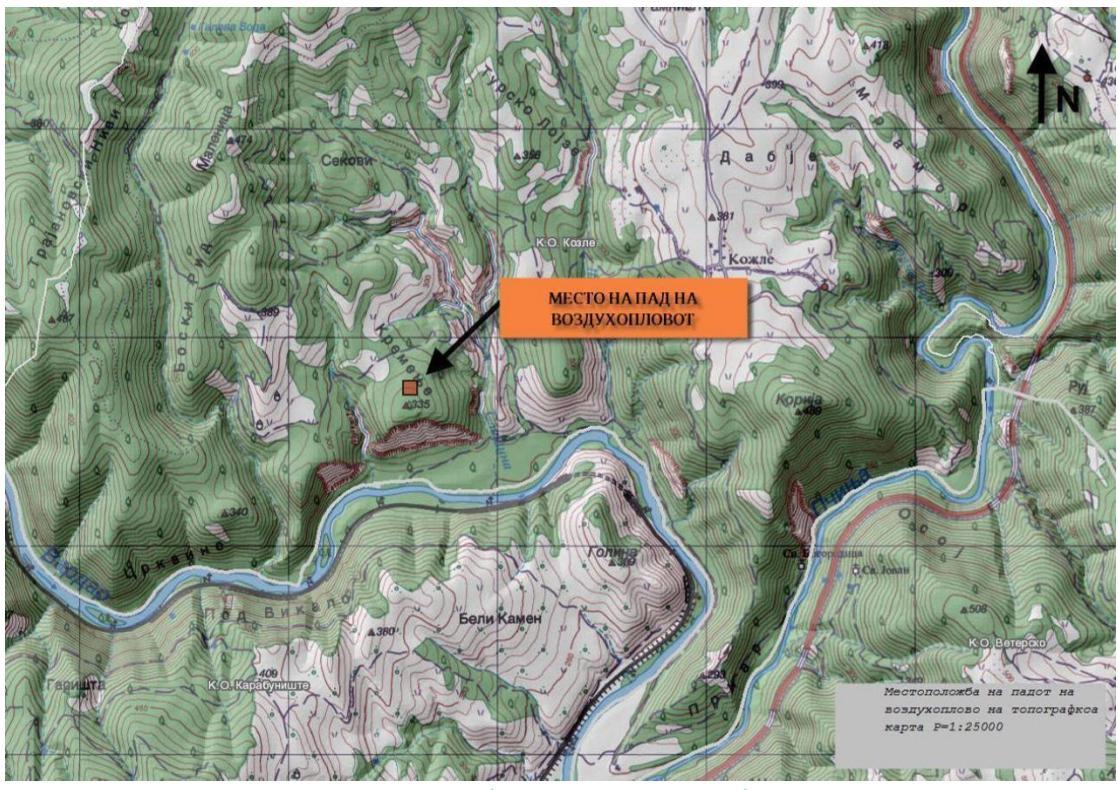
Image 4 Accident site – topographic map

The wider location of the fall of the aircraft is spatially located west of the village Kozhle with an air distance of about 1.6 km, and north-west of the mouth of the Pchinja River in the Vardar River with an air distance of about 2.1 km.

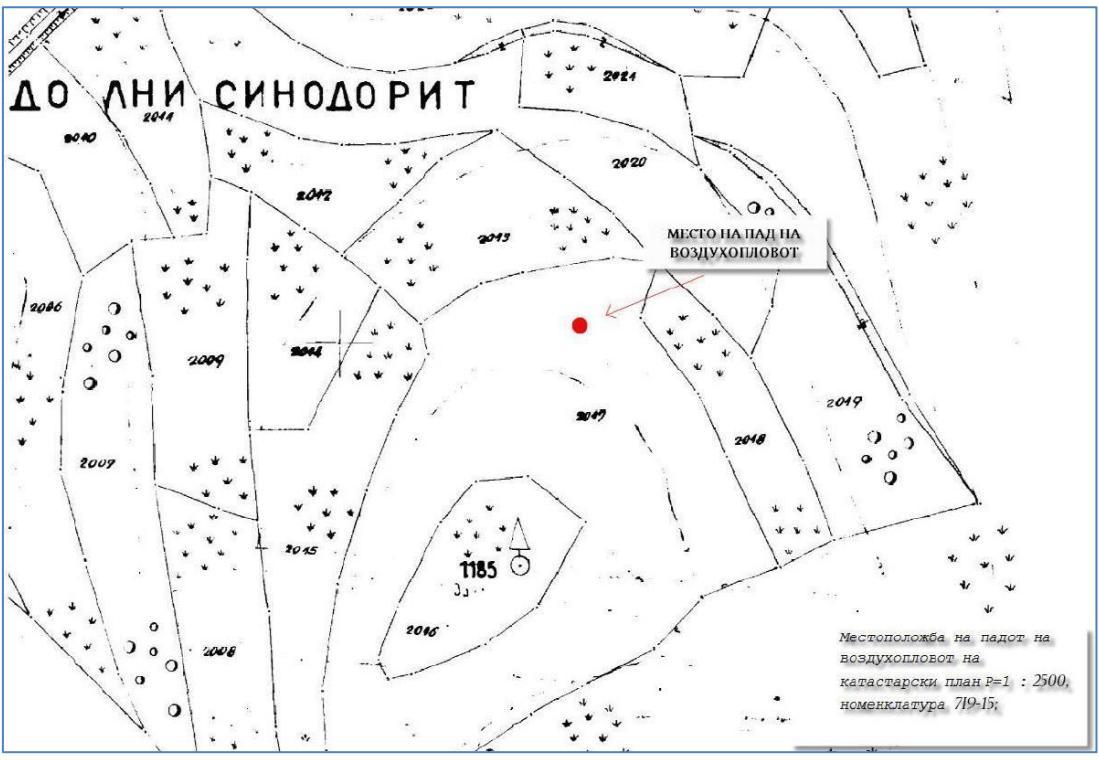
Image 5 Accident site – cadaster parcels

The place of the fall of the aircraft is located on the shadowy place Dolni Sinodorid in the wider area called Kremenje in the area of the village Kozhle, municipality of Petrovec. It is part of the Skopje administrative region located in the northern part of the Republic of Macedonia.
