Комитет за истрага на воздухопловни несреќи и сериозни инциденти  
Aircraft Accident and Incident Investigation Committee

**FINAL REPORT**  
**on a Serious Incident**  
**КИНСИВ 008/2025**  
**Airborne Near Mid-Air Encounter**  
between two aircraft:  
**Airbus A320 HA-LYS and Cessna 172 Z3-DCL,**  
in the vicinity of **Skopje International Airport**, at **FL040**,  
which occurred on **17 September 2025 at 05:45 UTC**.

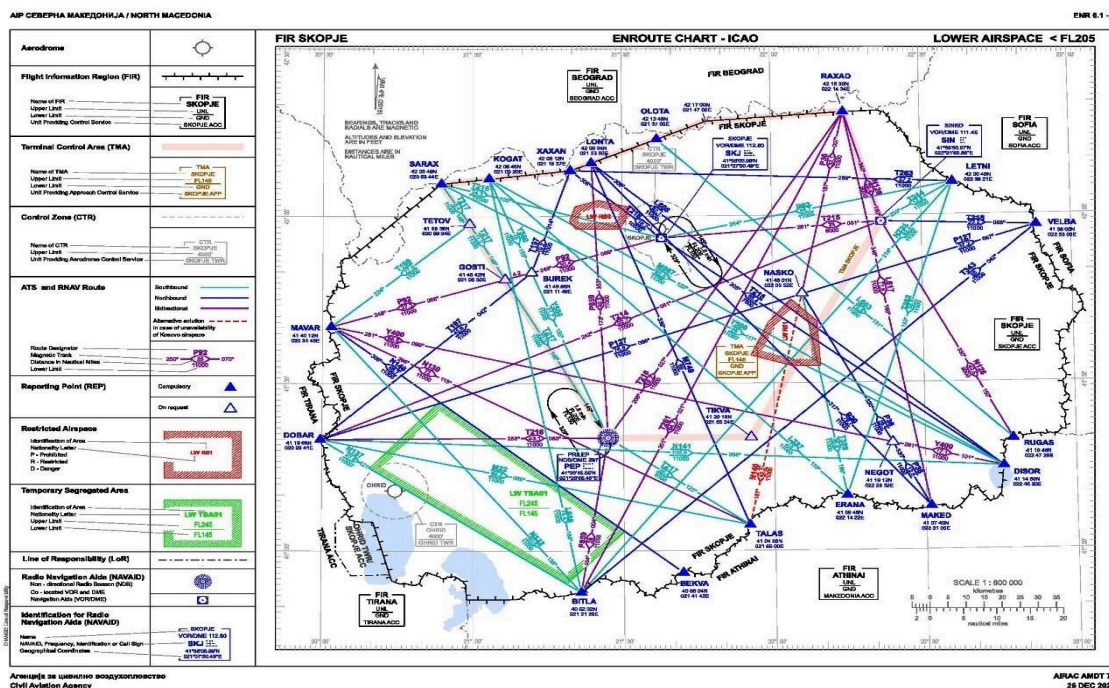
Figure 4: Airspace in Which the Critical Occurrence Took Place

Figure 4 presents the airspace of the Republic of North Macedonia. The critical occurrence took place in the northern sector of CTR Skopje, along the extended northern runway centreline, within the climb-out flight path of Runway 34, at an altitude of 4,000 ft.

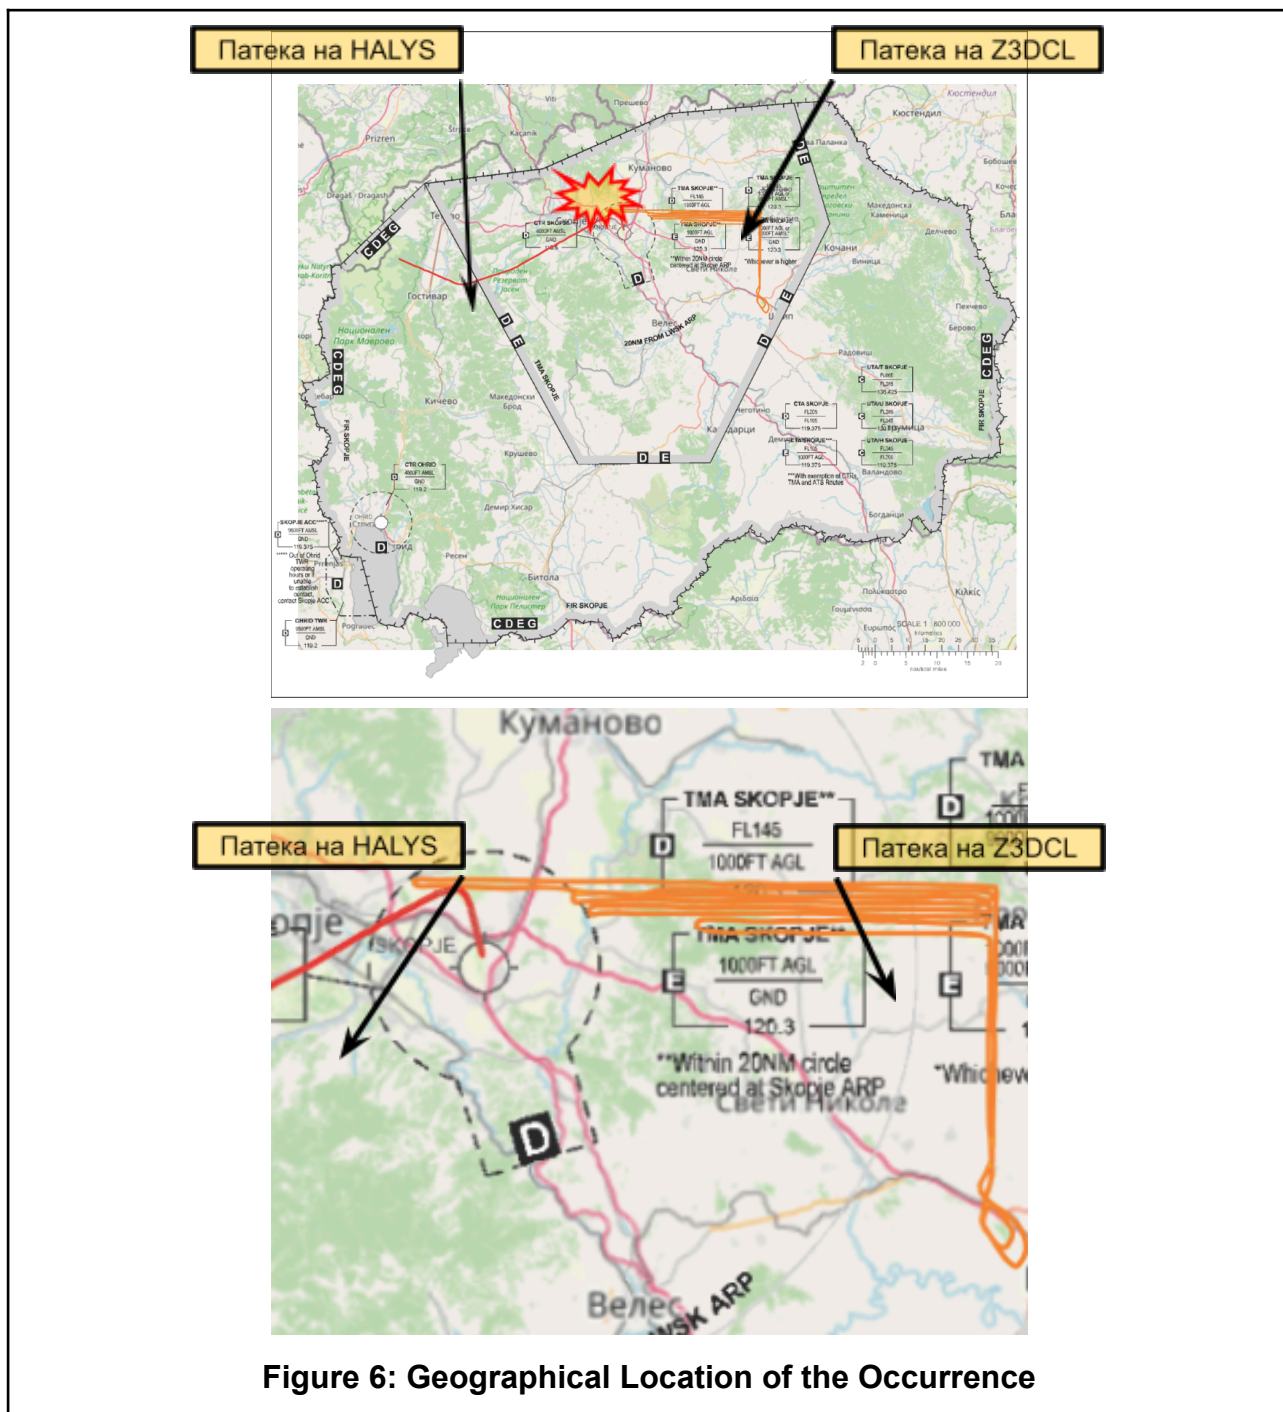
The critical occurrence took place 6 km north of Skopje International Airport and 12 km northeast of the city of Skopje, at an altitude of 4,000 ft.

The **orange line** indicates the flight path of **Z3-DCL** during its operation along **Route No. 64**. The **red line** indicates the flight path of **HALYS** after departure from **Skopje International Airport**.

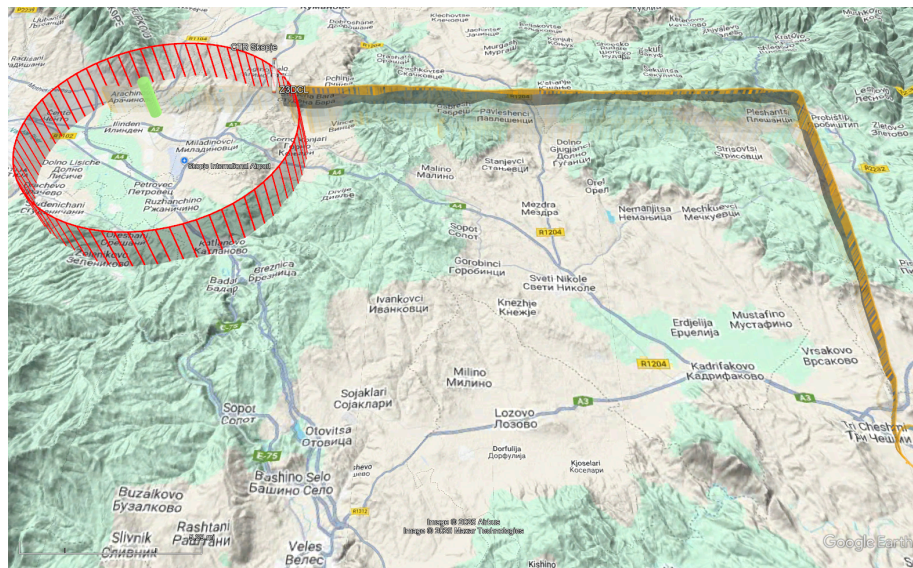
**Figure 9: Position of Z3-DCL Upon Entering Skopje CTR While Flying Westbound  
07:38 (Local Time)**

At **07:38 (local time)**, while maintaining an altitude of **4,000 ft**, the aircraft entered the **Skopje CTR** after flying approximately **20 NM** along the same track.

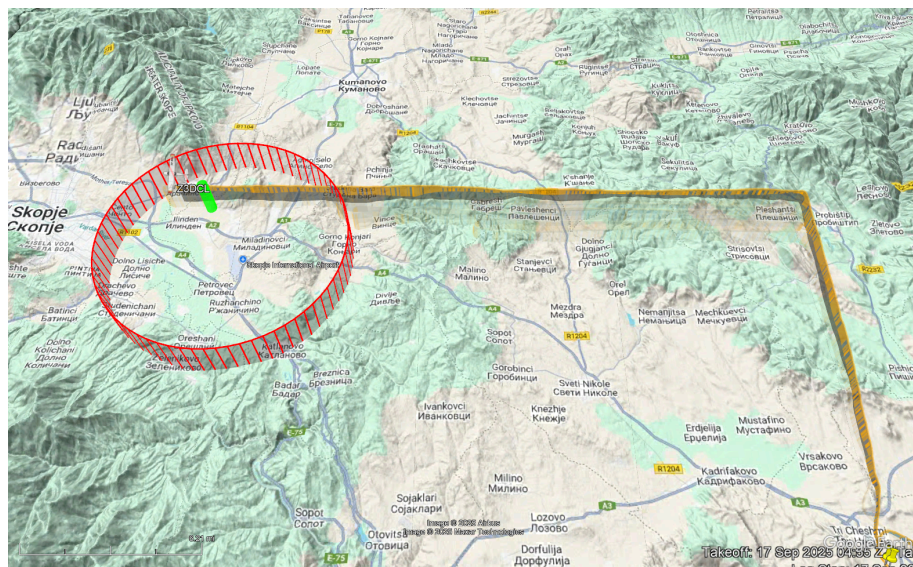
**Figure 10: Position of Z3-DCL on the Westbound Track  
07:43 (Local Time)**

The aircraft continued along the same track towards its western end. At **07:43 (local time)**, it initiated a **180° left turn** to commence the next survey track in an **eastbound** direction.

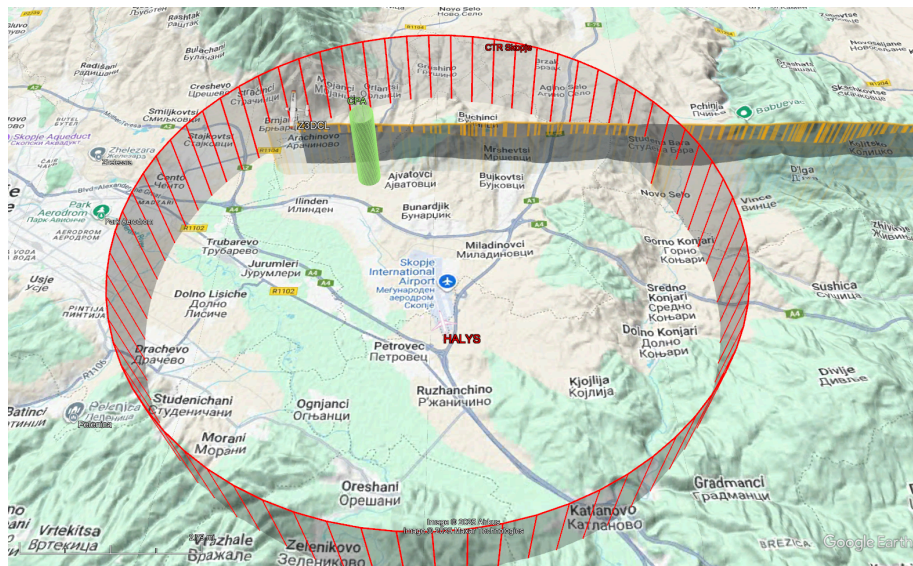
**Figure 13: Position of HA-LYS During Take-off**

At **07:43 (local time)**, the aircraft received take-off clearance from **Runway 34 at Skopje International Airport**.

This moment represented the beginning of the conflict situation that resulted in both aircraft approaching each other at an unsafe distance, creating a real risk of collision.

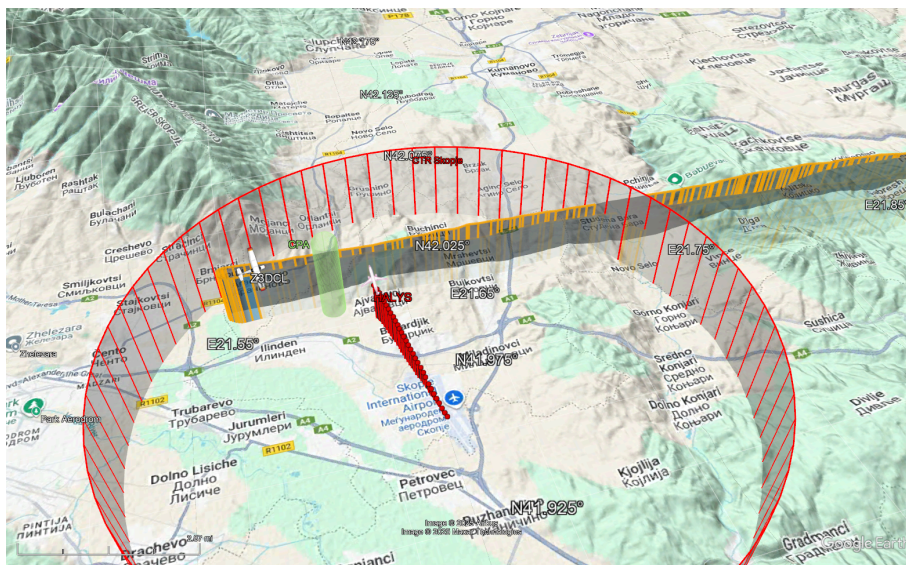
**Figure 14: Position of HA-LYS After Take-off, Before Initiating the Left Turn**  
**07:44 (Local Time)**

At **07:44:47 (local time)**, the aircraft established communication with **Skopje Approach (120.300 MHz)** and reported passing **3,700 ft in climb** and commencing a **left climbing visual turn towards waypoint GOSTI**.

The aircraft continued towards the **Closest Point of Approach (CPA)**. At this moment, both aircraft were converging towards the conflict point with a relative speed of approximately **300 KTS (5 NM/min, 155 m/s, 555 km/h)**.

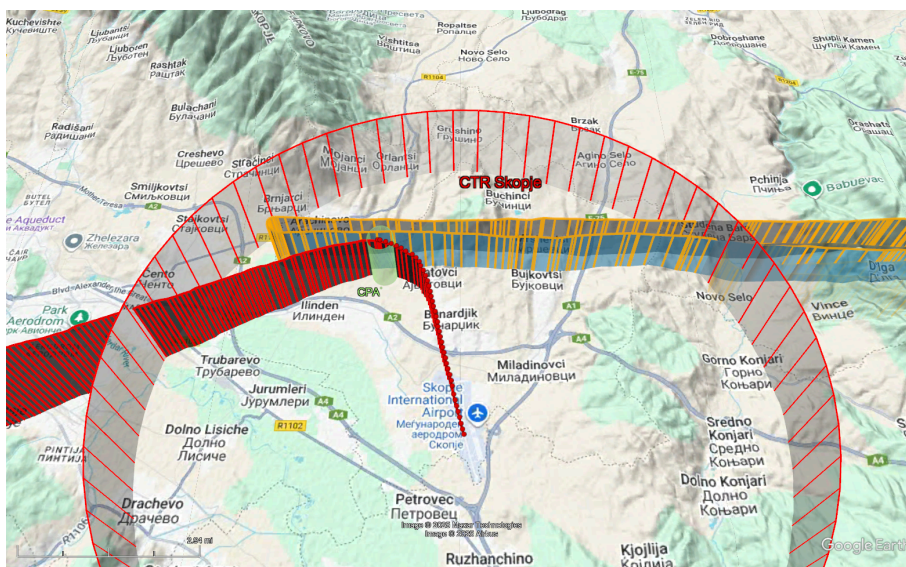
**Figure 16: Situation After Passing the Closest Point of Approach and Aircraft Separation**

After reaching the **Closest Point of Approach**, the aircraft passed clear of each other and the conflict situation de-escalated.

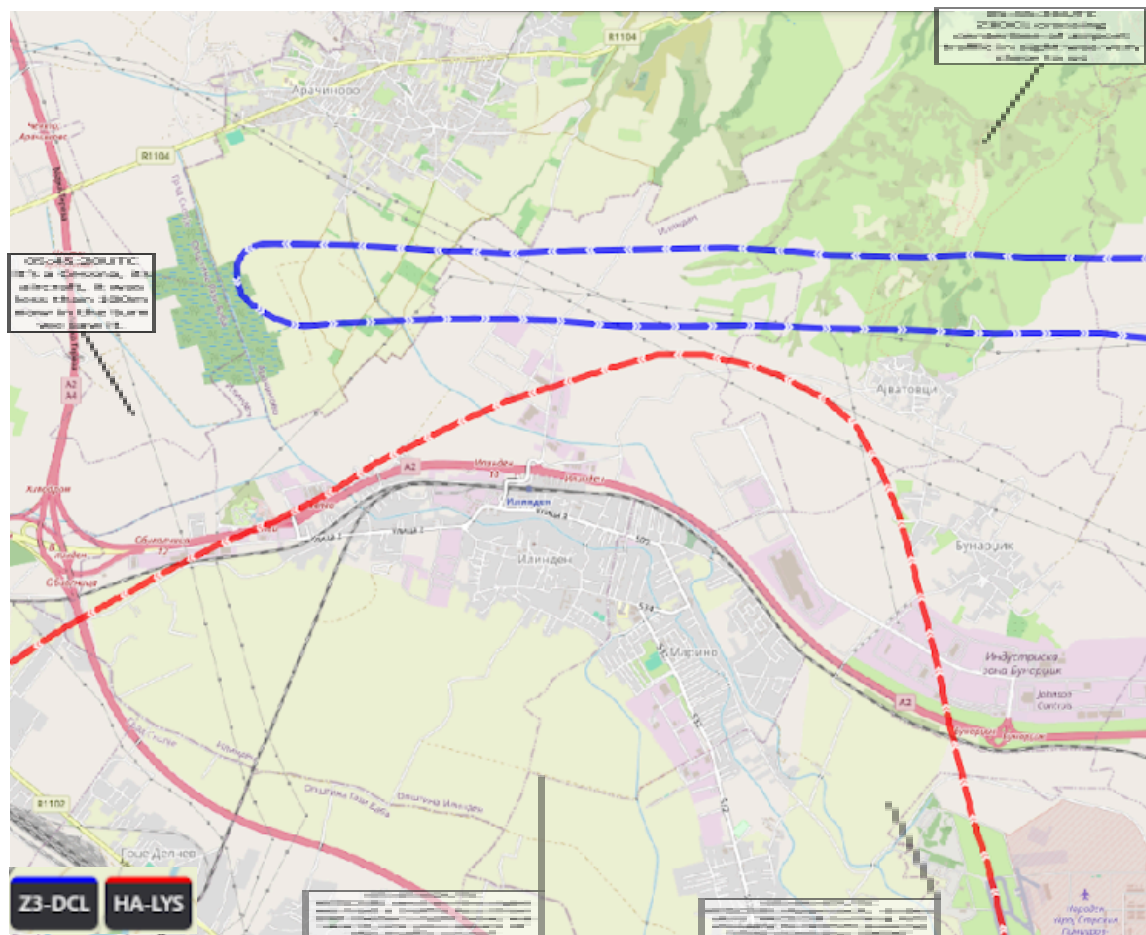
Figure 17: Horizontal representation of the aircraft trajectories

For the purpose of analysing the horizontal and vertical distance between the aircraft involved in this occurrence, GPS recordings of the flight paths were provided to the Committee.

Based on the analysis of the obtained recordings, the horizontal and vertical distances between the aircraft during the critical period were determined. All available recordings provided by the aircraft operators were analysed.
